## Field Safety Assessment Report by OZMOS, LLC

**Date of Assessment:** April 11, 2026  
**Location:** Pittsburgh, Neville Island Area  
**Assessor:** Shingo Ozaki  
Founder & Engineering Consultant

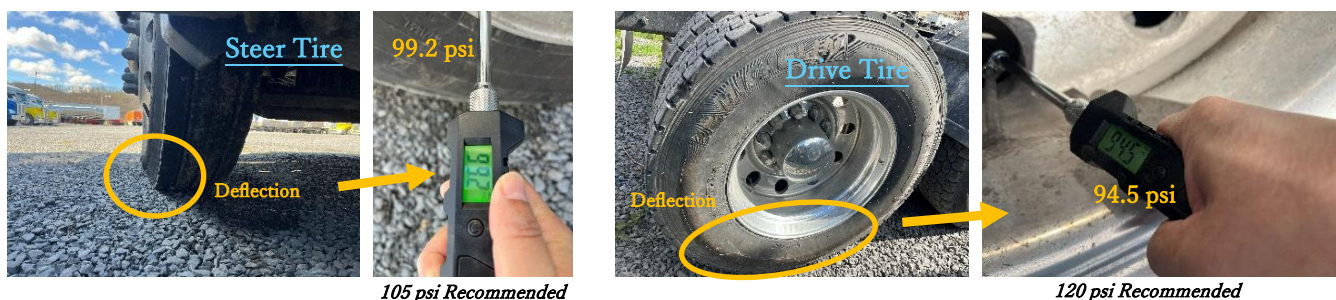
#### 4.1 Low Tire Inflation

During the inspection, both steer and drive tires were found operating at significantly lower pressures than recommended. Drive tires measured **94.5 psi** (recommended 120 psi), and steer tires measured **99.2 psi** (recommended 105 psi).

This condition was visually confirmed through noticeable **deflection** in the sidewall profile.

- ✓ Increased internal heat generation leading to accelerated casing degradation
- ✓ Higher likelihood of blowouts
- ✓ Reduced handling stability
- ✓ Accelerated irregular wear

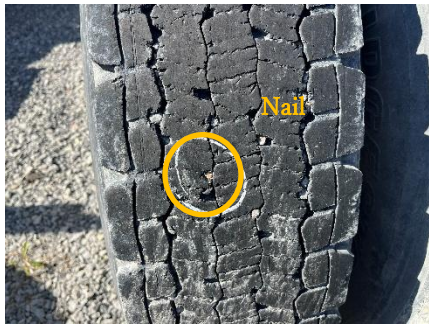
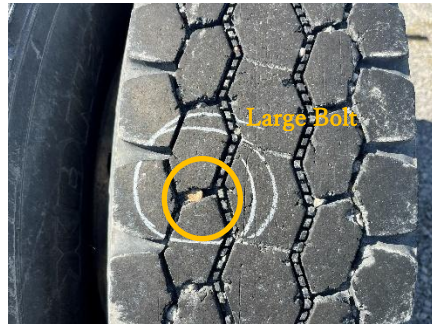
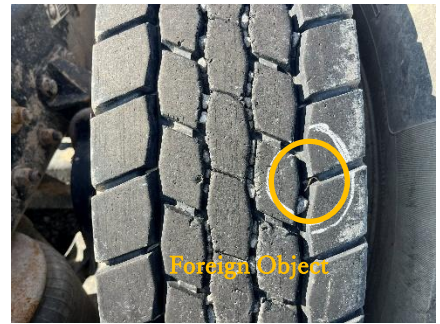
### 4.2 Embedded Nail & Bolts / Foreign Objects

Multiple tires were found with **nails**, **large bolts** and **thick wire-like objects** deeply embedded in the tread area. These objects had penetrated far enough to pose an immediate risk of air loss or structural damage.

- ✓ Slow or sudden air loss
- ✓ Penetration depth suggests potential casing damage
- ✓ Increased risk of roadside breakdown
- ✓ Elevated likelihood of catastrophic failure

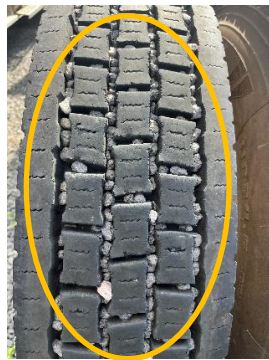
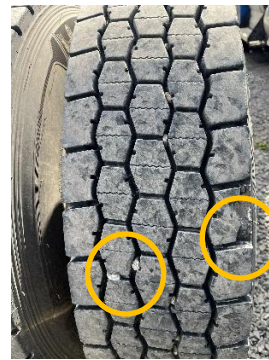
### 4.3 Stone Trapping & Tread Chuck

The fleet yards in this region were predominantly **unpaved gravel surfaces**, resulting in frequent stone trapping within tread grooves.

Significant differences in stone retention were observed depending on tread pattern, indicating that certain designs are unsuitable for this operating environment. This indicates a mismatch between tire design and operational environment.

- ✓ Accelerated tread wear
- ✓ Potential casing damage
- ✓ Increased risk of puncture
- ✓ Higher likelihood of retread rejection

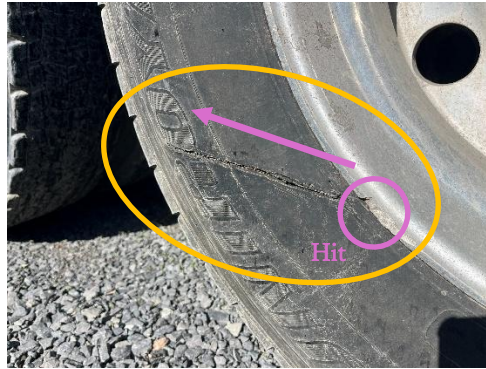
### 4.4 Sidewall Damage (Expert Witness-Level Analysis)

A drive tire exhibited a **localized sidewall cut** aligned with a corresponding **rim damage mark**, suggesting contact with a sharp, rigid object.

The cut depth indicates potential involvement of the **ply cords**, raising the possibility of structural compromise.

- ✓ The observed damage pattern is inconsistent with typical curb contact, which usually results in broader abrasion marks.
- ✓ The localized cut, aligned with rim damage, is more consistent with impact from a sharp, rigid object.
- ✓ This suggests a high likelihood of external impact as the primary cause of damage.
- ✓ This assessment is based on visual inspection and engineering judgment.

- ✓ High-risk condition requiring immediate removal
- ✓ Moisture intrusion → cord corrosion → Sudden Air Loss
- ✓ Potential for catastrophic failure during operation

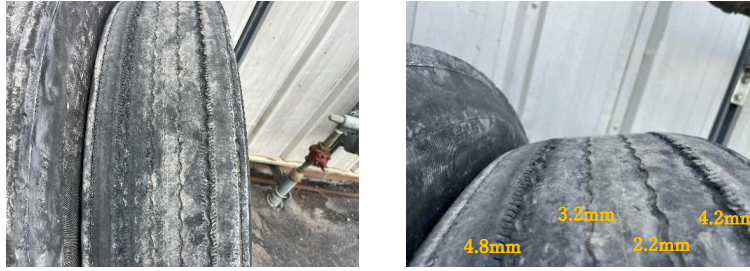
### 4.5 Removed Tire Inspection (Center Wear)

One removed tire was inspected and showed **center wear**, indicating operation under **excessively high inflation pressure**.

Tread depth measurements varied significantly (4.2 mm / 2.2 mm / 3.2 mm / 4.8 mm), confirming uneven wear progression. Uneven wear indicates suboptimal pressure management and load distribution.

- ✓ Reduced traction
- ✓ Shortened tire life
- ✓ Increased operating cost
- ✓ Potential for irregular wear–induced vibration
