## Field Safety Assessment Report by OZMOS, LLC

**Date of Assessment:** July 19, 2026  
**Location:** Pittsburgh, Zelienople Area  
**Assessor:** Shingo Ozaki  
Founder & Engineering Consultant

### 1. Executive Summary

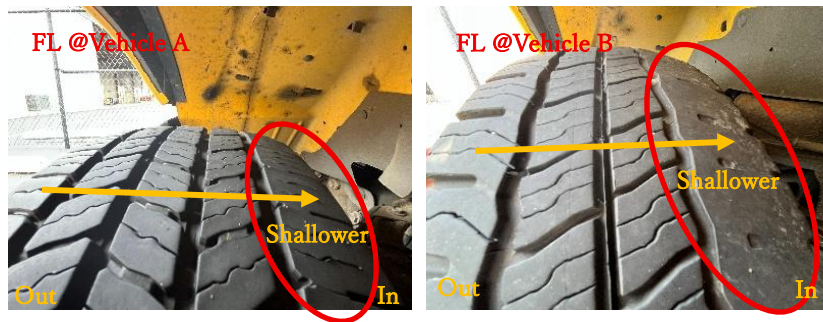
Irregular wear was observed on the inner rib of several steer tires, including tapered wear and localized heel-and-toe characteristics.

Potential contributing factors include:

- ✓ Alignment condition
- ✓ Inflation management
- ✓ Tire design interaction
- ✓ Operating conditions

- ✓ Accelerated tread wear
- ✓ Reduced tire service life
- ✓ Potential steering-performance variation

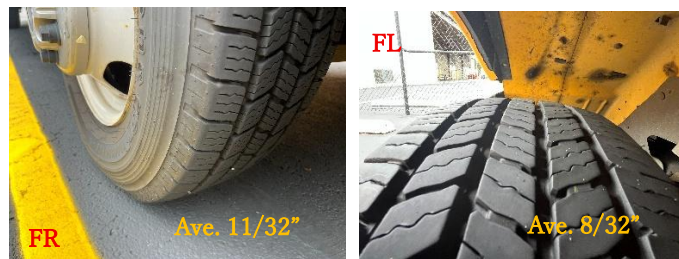
Vehicle A

Different tire products and remaining tread depths were observed across the left and right steer positions.

- ✓ Tread pattern design
- ✓ Remaining tread depth
- ✓ Wear progression

Although the observed tires remained serviceable based on visual observation, differences between left and right steer positions may result in different tire response characteristics and wear behavior.

- ✓ Potential differences in steering response
- ✓ Reduced consistency between left and right steer positions
- ✓ Uneven wear progression
- ✓ Potential influence on vehicle handling characteristics

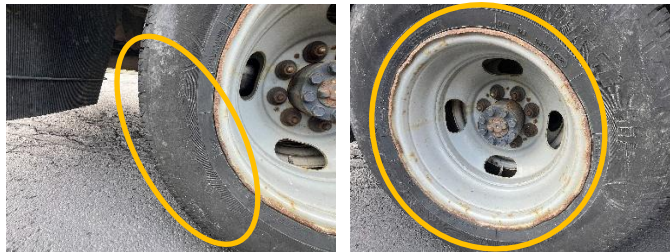
Sidewall scuffing and localized rim deformation were observed on a light-duty commercial vehicle. The observed condition may reflect repeated contact with curbs or other roadside obstacles, which can occur frequently in urban and last-mile delivery operations.

- ✓ Potential progression of sidewall damage
- ✓ Possible wheel or rim damage from repeated curb contact
- ✓ Increased need for periodic inspection of affected tire and wheel components

No immediate safety concern was established through external observation alone; however, continued monitoring can help identify progressive damage before it becomes more significant.

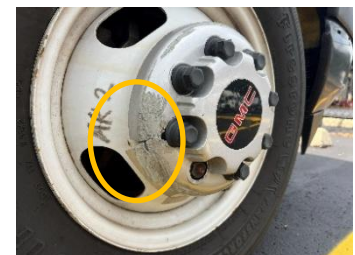
A damaged wheel-related component was observed on one steer position. Evidence of a previous repair was also visible. The exact condition and structural significance of the component could not be fully evaluated through external observation alone.

- ✓ Potential progression of component damage

- ✓ Possibility of component loosening or separation if deterioration progresses
- ✓ Need for periodic inspection and condition verification

Further inspection or replacement may be appropriate if the condition progresses or if component integrity cannot be confirmed.

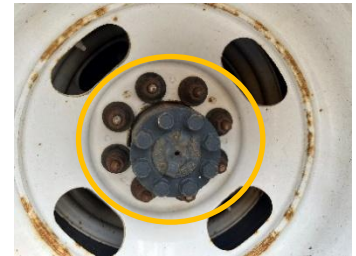
Surface corrosion was visible on portions of the wheel hardware. The observed condition alone does not establish a structural concern, and the extent of corrosion could not be determined through external visual observation.

- ✓ Potential progression of corrosion over time
- ✓ Possible deterioration of wheel hardware if corrosion becomes more severe
- ✓ Need for periodic monitoring during routine maintenance

Monitoring corrosion during routine maintenance may allow affected components to be addressed before more extensive deterioration requires additional repair or replacement.

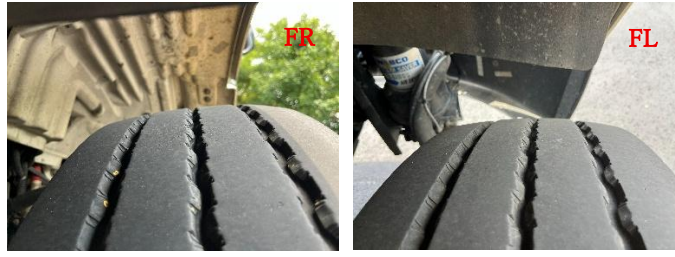
Minor step-down wear was observed on the outer rib of a steer tire installed on the rigid truck. The observed condition was less pronounced than the irregular wear identified on the light-duty vehicles but demonstrates that similar wear mechanisms may occur across different commercial vehicle applications.

- ✓ Potential progression of irregular wear
- ✓ Reduction in usable tread life if wear continues
- ✓ Need for continued monitoring of tire wear progression

Early recognition of irregular wear provides an opportunity to investigate contributing factors before substantial usable tread is lost.
